OF THE NAYLOR CAR CLUB

TOOLBOX

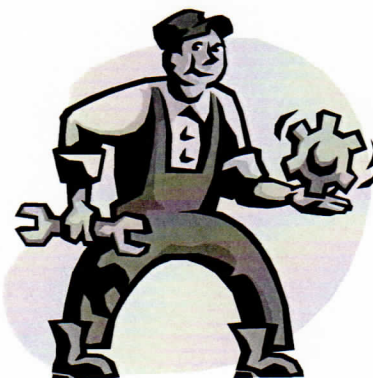
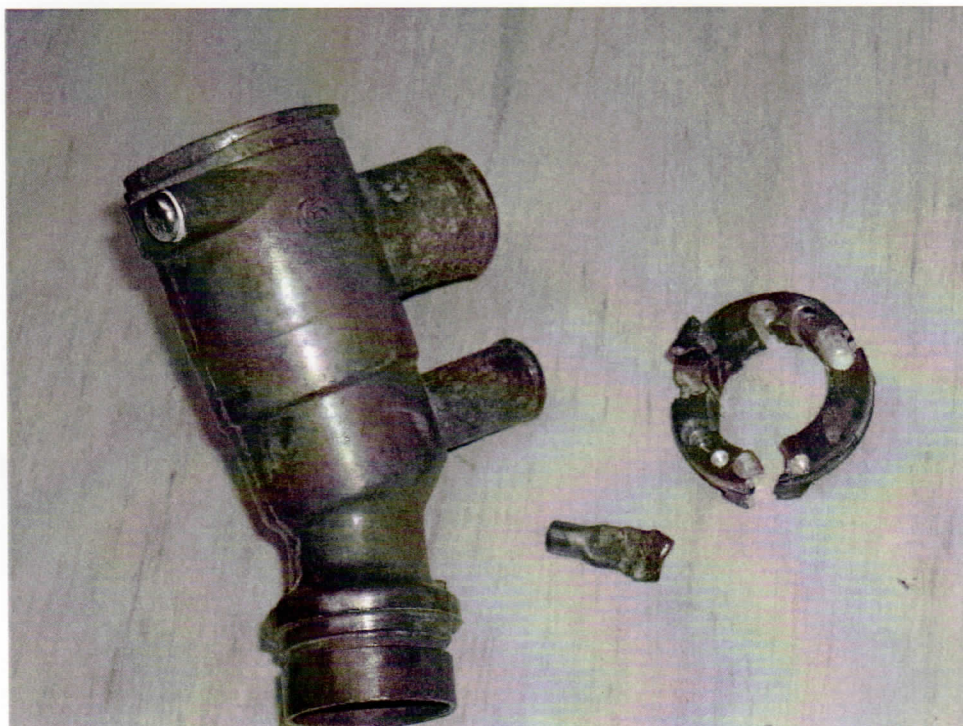
This thermostat housing is from one of the later Sherpa vans fitted with the "O" series engine similar to our Naylor's. It has the same part no (CAM 58050) unlike the Ambassador & Princess car CAM 5757 which will not fit our Naylor's, the only difference is that it has an extra small pipe fitting at the top which I believe went to the expansion tank. I acquired one in a poor state with the thermostat well & truly stuck. After leaving it soaking in diesel for several weeks it still would not budge. Not wanting to split the housing as it seems has happened before, (*NN no 39 p18*) I carefully snapped off the top of the thermostat and drilled pilot holes round the flat area. The holes were enlarged with a bigger drill taking care to keep the drill parallel with the inside of the housing so as not to damage it. A hacksaw blade was then used to cut "V" shapes towards the holes. Using a short metal bar and tapping on the inside of the thermostat it came away from the housing quite easy. The small metal pipe attached to the top of the housing was then put into a vice and with a little twist was pulled out. A thread was cut & a suitable bolt found & fitted using a plumbers white sealing tape. The picture shows the housing with the bolt fitted where the pipe was removed & the broken thermostat along with the small removed pipe.
